## Periprosthetic fracture of the tibial plateau after unicompartmental knee arthroplasty

The authors report three cases of unicompartmental knee arthroplasty (UKA), complicated with perioperative periprosthetic fracture of the tibial plateau. The surgical technique was held responsible in all cases. The initial treatment was different in every case ; all patients ultimately underwent revision total knee arthroplasty with a good functional outcome.

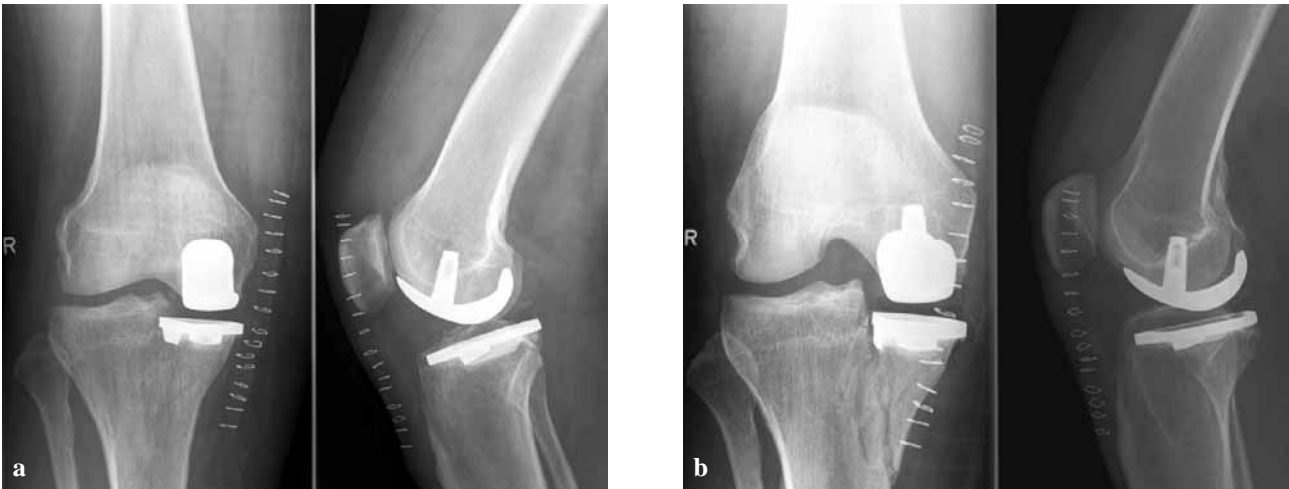
**Fig. 1.** — **a)** above : radiographs 1 day PO shows good alignment of the prosthesis ; **b)** below : Radiographs 6 days PO shows a displaced periprosthetic fracture of the tibial plateau (Case 1).

physiotherapy session. Radiological imaging showed a periprosthetic tibial plateau fracture (fig 1b, fig 2). Close examination of the initial post-operative radiological image revealed subtle vertical radiolucent fissures through the medial tibial plateau and a relatively peripheral positioning of the tibial implant. Three days later, the patient underwent open reduction and internal fixation of the tibial plateau fracture (fig 3). Nonetheless, pain and reduced mobility persisted for 6 months and radiological imaging showed an abnormal caudal position of the tibial implant and a medial subluxation of the knee. Six weeks later, revision TKA was performed using a medial augmentation spacer (fig 4).

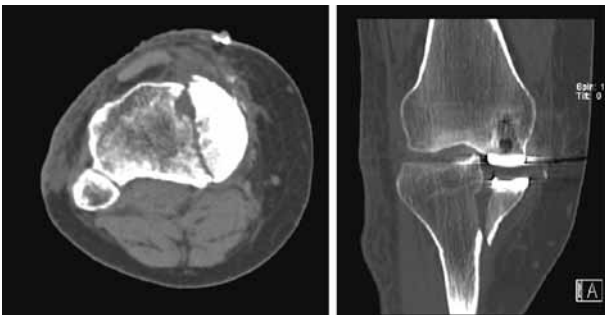
**Fig. 2.** — CT 8 days PO shows a vertical fracture starting lateral from the tibial component with caudal displacement of the medial tibiofemoral compartment (Case 1).

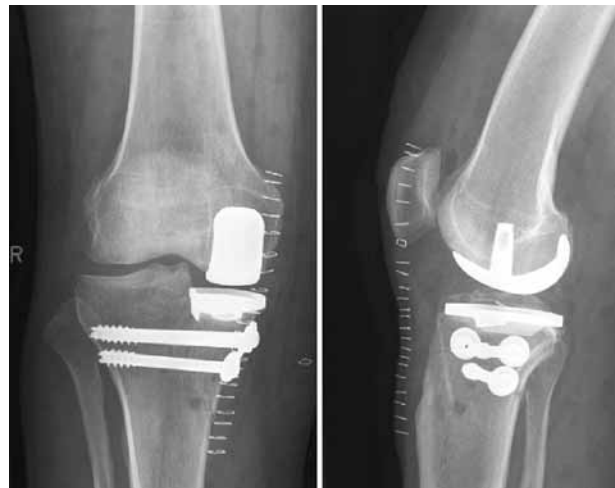
**Fig. 3.** — Radiographs after osteosynthesis of the tibial plateau fracture shows good realignment of the tibial plateau fracture (Case 1).

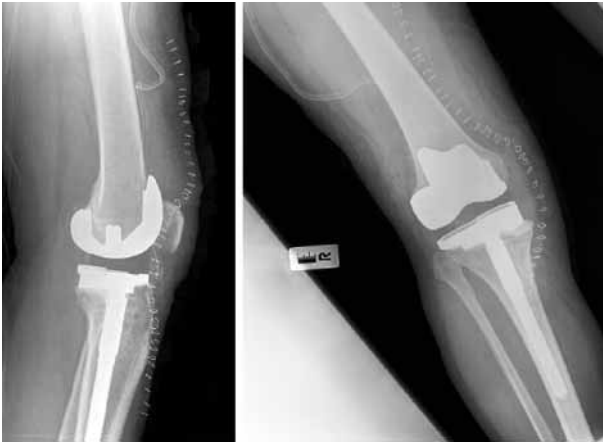
**Fig. 4.** — Radiographs after revision total knee arthroplasty show good alignment of the prosthetic components (Case 1).

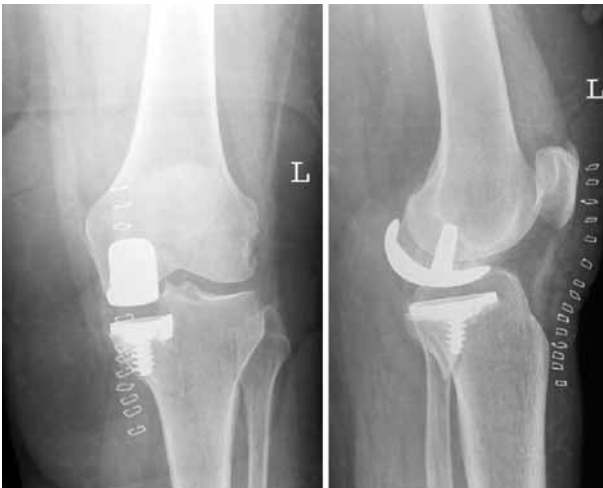
**Fig. 5.** — Radiographs immediately PO show a minimally displaced oblique posteromedial periprosthetic fracture (Case 2).

compartment. Radiological imaging showed moderate narrowing of the medial tibiofemoral joint space and osteochondral damage of the left femoral condyle. After three years of conservative treatment the patient underwent a unicompartmental knee arthroplasty in our department. During implantation of the tibial component, a fissure occurred in the proximal tibia. Postoperative radiographs (fig 5) and CT (fig 6) showed a periprosthetic tibial plateau fracture. The patient was not allowed to bear full weight on the operated knee for

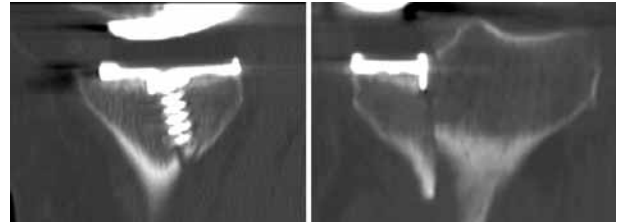
**Fig. 6.** — CT one-day PO shows an oblique fracture with cortical interruption of the posteromedial tibial metaphysis and slight displacement of the medial tibial plateau (Case 2).

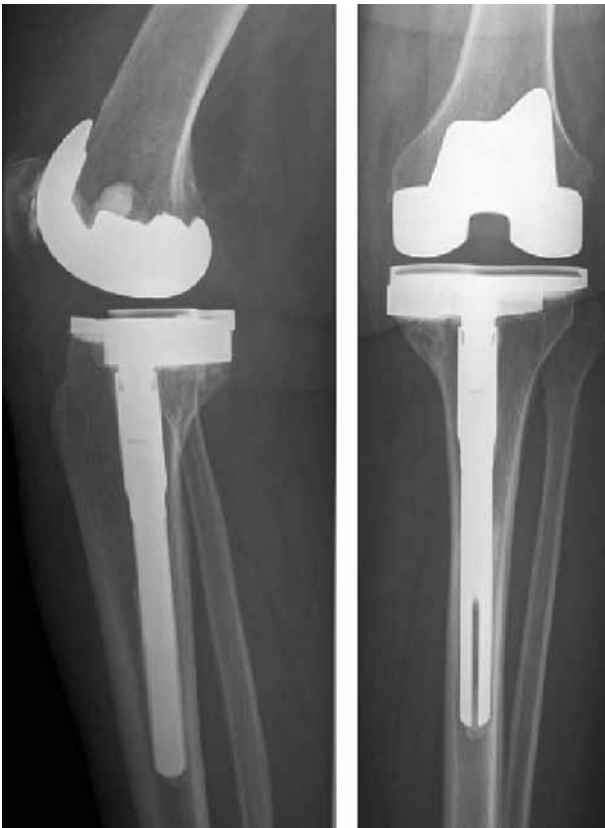
**Fig. 7.** — Radiographs after revision TKA show good position and alignment of the prosthesis. No signs of loosening (Case 2).

Fifteen months after the index operation, a revision total knee arthroplasty (Profix Oxinium PS, Smith & Nephew, USA) with use of a medial augmentation spacer was performed. Postoperative radiographs showed good position and normal alignment of the prosthesis (fig 7). Four months after operation, the patient had an adequate functional outcome with minor episodes of nocturnal pain. Flexion exceeded 90°, a mild extension deficit of 3° persisted.

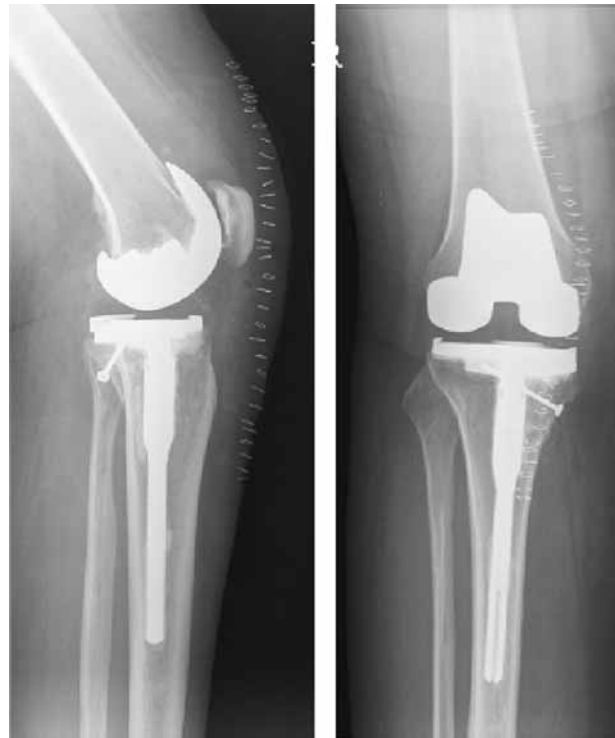
**Fig. 8.** — Radiographs immediately PO show conversion total knee arthroplasty and additional screw stabilisation with good position of prosthetic implants (Case 3).

A 45-year-old lady presented to our department with persisting pain at the medial aspect of the right knee following local trauma. Radiological imaging showed medial joint space narrowing, some osteophyte formation and bone loss in the medial tibiofemoral compartment. Avascular necrosis was excluded. Sixteen months later no improvement was noted following conservative treatment and hyaluronic acid infiltration. A unicompartmental knee arthroplasty (Profix, Smith & Nephew, USA) was performed. Intraoperatively, conversion to total knee arthroplasty was required due to collapse of the medial tibial plateau. An additional stabilisation with a cancellous screw was made to prevent subsequent collapse (fig 8). Postoperatively, the patient was not allowed to bear full weight on the

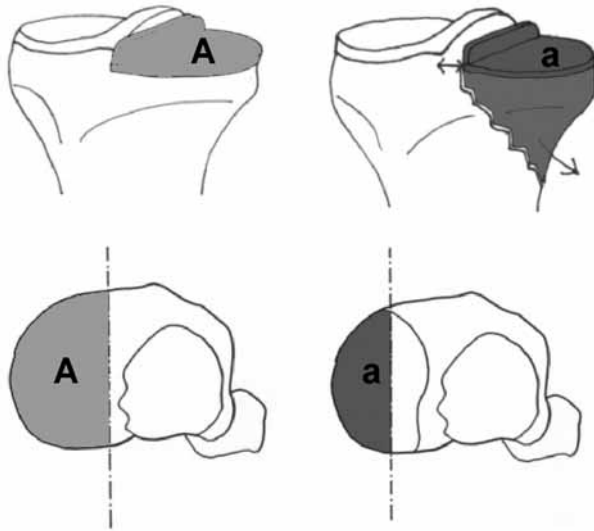
**Fig. 9.** — Undersizing as well as peripheral positioning of the tibial component reduces the area (A) on which the load will act. This results in higher stresses on a smaller and eccentric region of the tibial plateau, predisposing to tibial plateau fracture.

Finally we would like to highlight the importance of adequate sizing of the tibial component. Oversizing induces large forces being exerted on the non-supported portion of the tibial tray in weight-bearing flexion, which result in stress fractures. Undersizing or peripheral positioning of the tibial component results in inadequate load transmission between the tibial component and the proximal tibial plateau. The stress will be concentrated on a small and eccentric region of the tibial plateau leading to tibial plateau stress fractures (fig 9).
