## Lengthener loosening in a reversed shoulder prosthesis : A case report

*From the Rijnstate Hospital, Arnhem, The Netherlands*

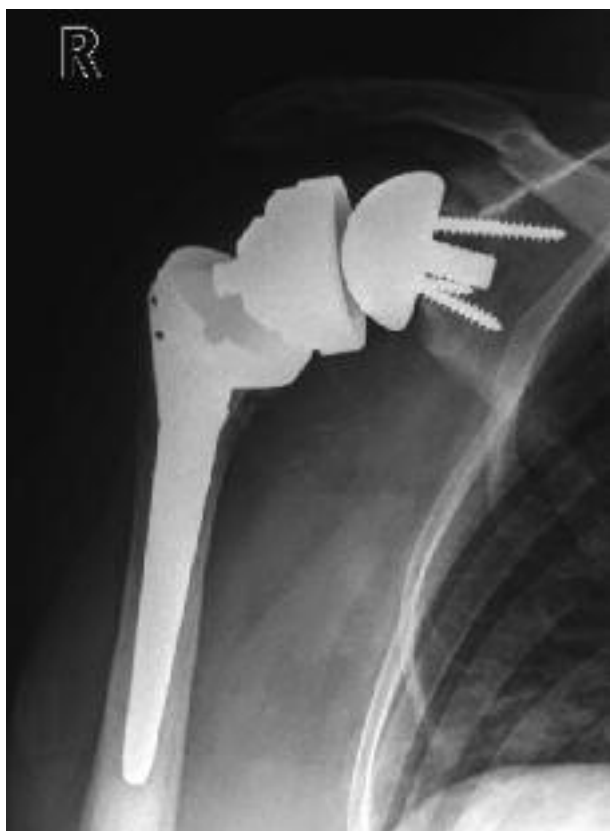
**Fig. 1.** — Loosening of the humeral 9-mm lengthener. Note inferior osteolysis due to impingement of the retentive cup.

Radiography showed loosening of the 9-mm lengthener from the humeral stem (fig 1). The polyethylene insert was still articulating with the glenoid component. During revision operation a severe grey-coloured synovitis was noted (fig 2). A synovectomy was performed and pathological investigation showed severe metallosis and fibrosis. The loose 9-mm lengthener with the retentive polyethylene insert was removed. When inspecting the insert the articulating polyethylene surface was found to have severe wear, and the screw thread of the lengthener was badly damaged (fig 3a, b). The cemented humeral stem and the non-cemented glenoid components were neither damaged nor loose. We noted significant signs of inferior impingement which radiographically could be classified as a grade II notching according to the radiographic scoring system proposed by Valentini *et al* (13). The

screw thread of the humeral stem was inspected ; it was not grossly damaged. A new 9-mm lengthener and a new lateralised 36-mm retentive humeral cup were inserted. To avoid future re-loosening we added cement during lengthener fixation. Upon testing, the lengthener could not be loosened by manual force. Three months postoperatively the patient did well with VAS scores of 3 for function and 2 for pain (respectively 6 and 7 preoperatively). Average abduction force was 108% compared with the non-operated left side. (28N, MecMesin® myoabduction gauge). Radiographs showed no prosthesis related problems or progress in inferior notching.

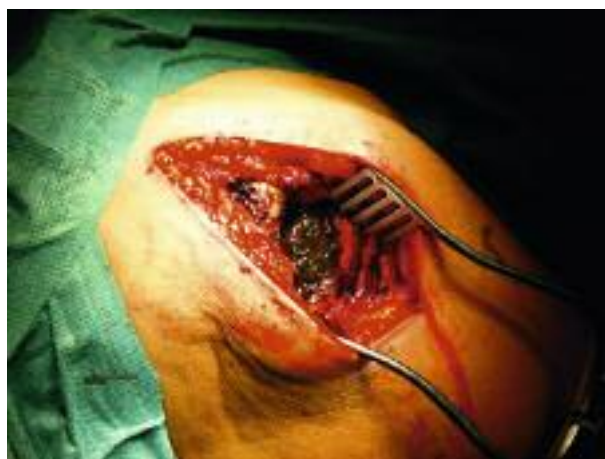
**Fig. 2.** — Severe metallosis of the joint synovium

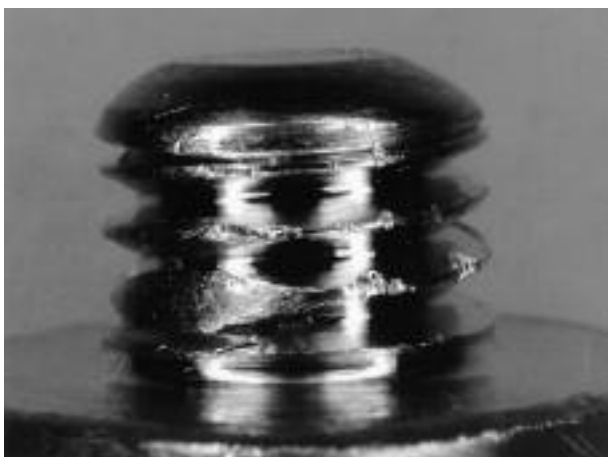
**Fig. 3a.** — Damaged screw thread of the 9 mm lengthener

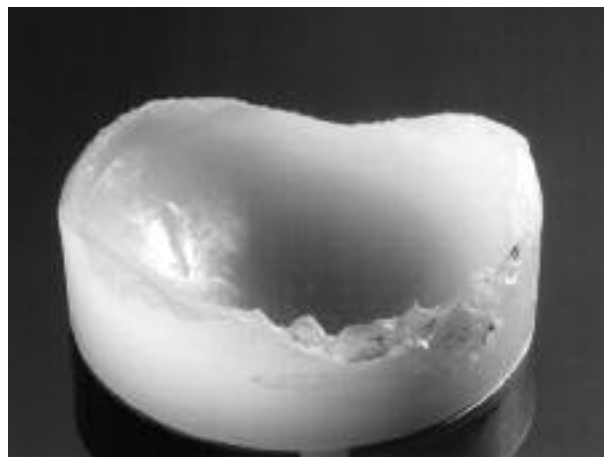
**Fig. 3b.** — Anterior inferior damaged polyethylene insert of the lateralised retentive humeral cup.
