Failure of the titanium trochanteric Gamma nail in ununited metastatic fractures

Michael MAES, Ytsje DEBOER, Karl BRABANTS

From ZNA Hospitals Middelheim, Antwerp, Belgium

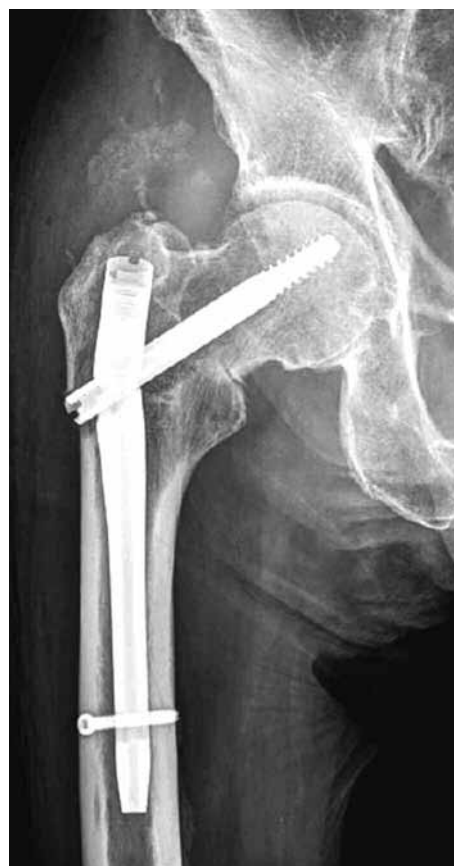
Clinical follow-up at 6 and 12 weeks postoperatively revealed pain in the right hip region during weight bearing, suggesting delayed union. Eight and a half months postoperatively the patient was admitted to the emergency department. Weight bearing and passive manipulation of the right hip were impossible. Radiographs showed mechanical failure at the level of the aperture for the lag screw (Fig. 1).

Fig. 1. — AP radiograph of the right hip showing mechanical failure at the level of the aperture for the lag screw in an unstable intertrochanteric fracture with clearly visible cortical defect laterally.

due to overload. The radiograph shows the broken titanium nail and an unstable intertrochanteric fracture with a clearly visible cortical defect laterally (Fig. 1).

The broken Gamma-nail was removed and replaced by an Intertan® IM-nailing device (Smith & Nephew, Memphis, USA). Despite this procedure a painful pseudarthrosis developed. Deteriorating general condition and progression of metastatic disease made further revision surgery impossible.

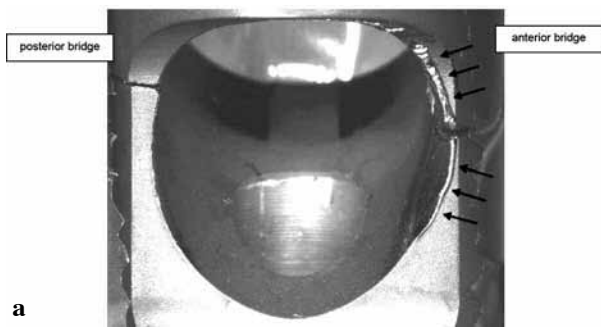
More detailed examination demonstrated significant chamfer-like and sharp edged damage on the lateral edge of the anterior bridge in the proximal and distal fragments of the nail. The lateral edge of the anterior bridge had become damaged due to contact with the step drill. The lateral edge of the posterior bridge of the proximal fragment of the nail on the other hand appears nearly undamaged (Fig. 2a). The fracture surfaces of both bridges of the nail have a smooth topography over the whole cross section. Both surfaces of the bridges have features of a fatigue fracture (semi-circled lines, “rubby shiny areas) (Fig. 2b). These lines of rest

Fig. 2a. — Sharp edged drill damage to the proximal and distal lateral edge of the anterior bridge (arrows). The lateral edge of the posterior bridge of the proximal fragment of the nail on the other hand is almost undamaged.

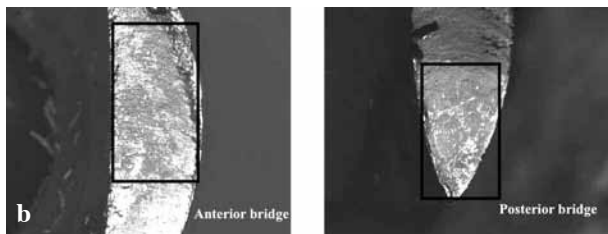
Fig. 2b. — *Left* : Semi-circled lines as a feature of a fatigue fracture. *Right* : Smooth surface over cross-section without deformation indicate a fatigue fracture.

and the missing deformation indicate a fatigue fracture. A hardness test according to Rockwell and translation revealed the tensile strength of the material (titanium) being within specified values.

Considering the orientation of the lines of rest (running from lateral towards medial), the main fatigue crack originated laterally, progressed through the cross-section and ended medially with signs of friction and material deformation towards the outside. An additional sharp edge – caused intra-operatively – contributed to the origin of a crack in the anterior bridge laterally followed by the delayed breakage of the posterior bridge. Additionally an angled breakage line – running from lateral to medial – was defined. This is usually caused by high torsional load application.

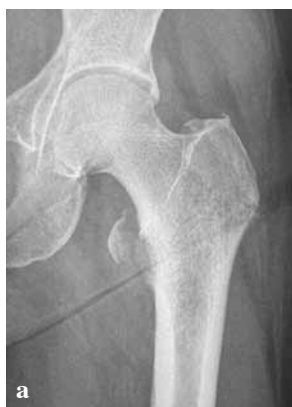
In this case the nail broke in a fatigue fracture after an implantation period of approximately five and a half months due to overload. The radiographs showed the broken titanium nail in an unstable inter-trochanteric fracture with clearly visible cortical defects (Fig. 3b).

Fig. 3a. — Undisplaced intertrochanteric fracture of the left hip.

Fig. 3b. — Failure of the titanium trochanteric Gamma nail on the level of the aperture for the lag screw.

The broken Gamma nail was removed and replaced by an Intertan® IM nailing device. At follow-up the patient was ambulant but presented with a new pathologic lesion in the head of the right femur. The left side showed no radiological consolidation with lag screw cut-out of the femoral head. Due to collapse on the right side with the failing Intertan® device on the left, the patient received a one-stage bilateral hemiarthroplasty.
