FALSE ANEURYSM IN AN ILEOFEMORAL DACRON® GRAFT AFTER TOTAL HIP ARTHROPLASTY

A. FRÍAS PÉREZ, F. J. GARCÍA GARCÍA, J. A. ORTIZ GÓMEZ,
J. R. PRIETO MONTAÑA, F. GONZALO VIVAR

A 54 year-old woman patient had received a complete Zweymüller-type prosthesis of the left hip 9 years previously. The heat generated by the setting of the cement produced a thrombosis of the common femoral artery, and an ileofemoral Dacron® graft was made. After the 9 year period, the acetabular component was clearly loosened, and a replacement was attempted during which the existence of a pseudoaneurysm, the result of erosion of the Dacron® graft by the cement pin, was discovered.

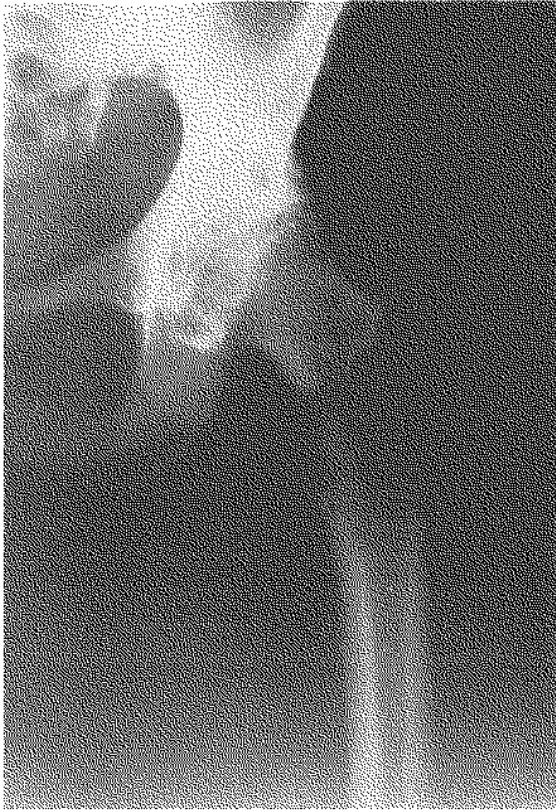
Fig. 1. -- Left coxarthrosis, immediately before operation.

A 46 year-old woman consulted in December 1982 because of pain in the hips and both knees of 6 years' duration. The radiological study confirmed the existence of bilateral coxarthroses more severe in the left hip (fig. 1). Interesting history included exogenous obesity which was being treated by the endocrinology department with a 1000 calorie diet, a 6 year history of arterial hypertension well controlled on a salt-free diet, and lumbar spondylosis.

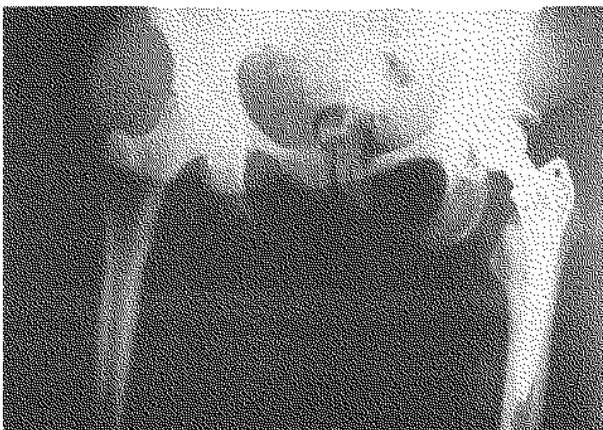
Fig. 2. - Immediately after operation. Complete Zweymüller-type cementless prosthesis.

In February 1983 she received a total Zweymüller prosthesis without cement through a Watson-Jones approach (fig. 2). The acetabulum was not deep and there was little internal or posterior wall, so an Ender component was not considered viable. Therefore a cemented Müller component was used. At the end of the surgical intervention,

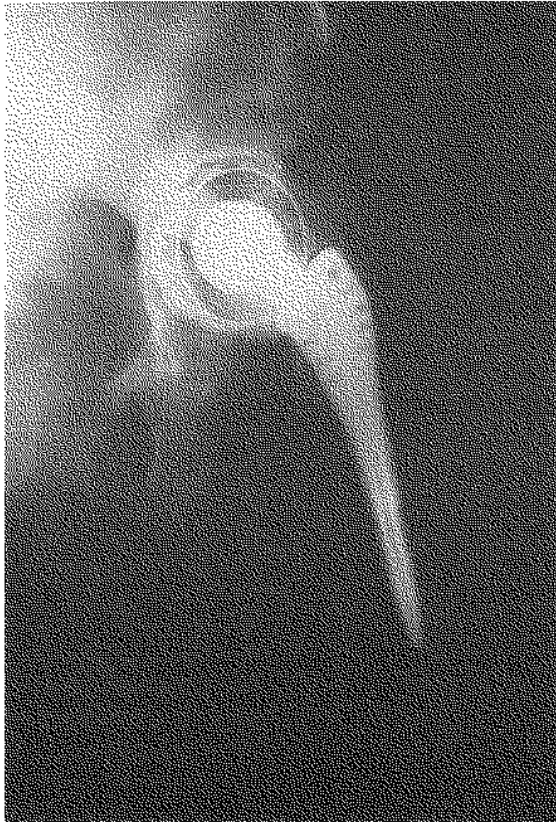
Fig. 3. — Loosening and protrusion of the acetabular cup component after 8 years.

After 8 years there was loosening of the acetabular cup component, which appeared to have protruded into the pelvis. In September 1991 an examination of the prosthesis was carried out. On physical examination of the component, a hematoma began to drain and later to bleed so profusely that it became necessary to request a cardiovascular consultation. The vascular surgeons made an anterior opening from the abdomen to the inguinal ligament. The anatomy seemed totally confused, but an 8 cm pulsating pseudoaneurysm could be seen. After the removal of the cement which had passed through the back of the component, the iliac and common femoral arteries were clamped, the pseudoaneurysm was dissected and the existence of an orifice in the vascular dacron prosthesis could be seen. The perforated dacron prosthesis was then removed and a new terminoterminal teflon graft was placed (fig. 4). The Gilderstone technique was used on the patient. Even though prophylactic antibiotic treatment was

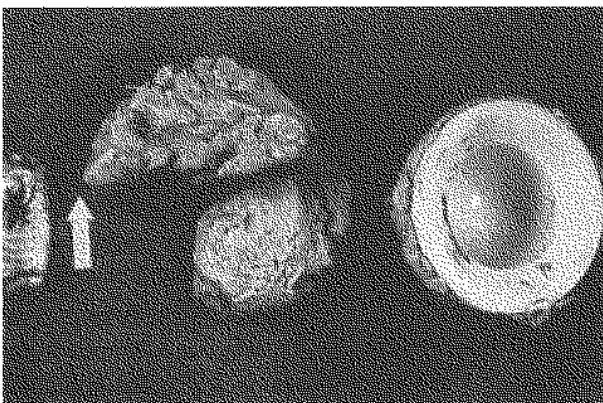
Fig. 4. — Material extracted during the examination of the prosthesis. The acetabular component of the prosthesis can be seen protruding into the endopelvis, the point (arrow) of which has eroded the dacron vascular prosthesis (see orifice).

The case with which we are concerned was one where, after a total arthroplasty, the heat generated by the setting of the cement caused burning and thrombosis in the common femoral artery which necessitated an ileofemoral Dacron® graft during the operation. An attempt at replacement revealed a pseudoaneurysm caused by the erosion which the component had progressively caused in the vascular prosthesis. In the literature we have found no cases of pseudoaneurysm as a consequence of the erosion of the acetabular cemented component of a total hip arthroplasty on a vascular dacron graft.

to the neighboring vascular structures, but could also produce a chronic vascular lesion of the pseudoaneurysmal type as a consequence of the use to which the vascular graft is subjected when the prosthetic component is loosened. This injury mechanism, demonstrated in our case, would support the hypothesis of a chronic vascular lesion already suggested by J. D. Dorr (3).
